INDOOR AIR QUALITY ASSESSMENT

**Henry A. Yelle Elementary School
64 West Main Street
Norton, Massachusetts**

Prepared by:
Massachusetts Department of Public Health
Center for Environmental Health
Bureau of Environmental Health Assessment
Emergency Response/Indoor Air Quality Program
December 2004

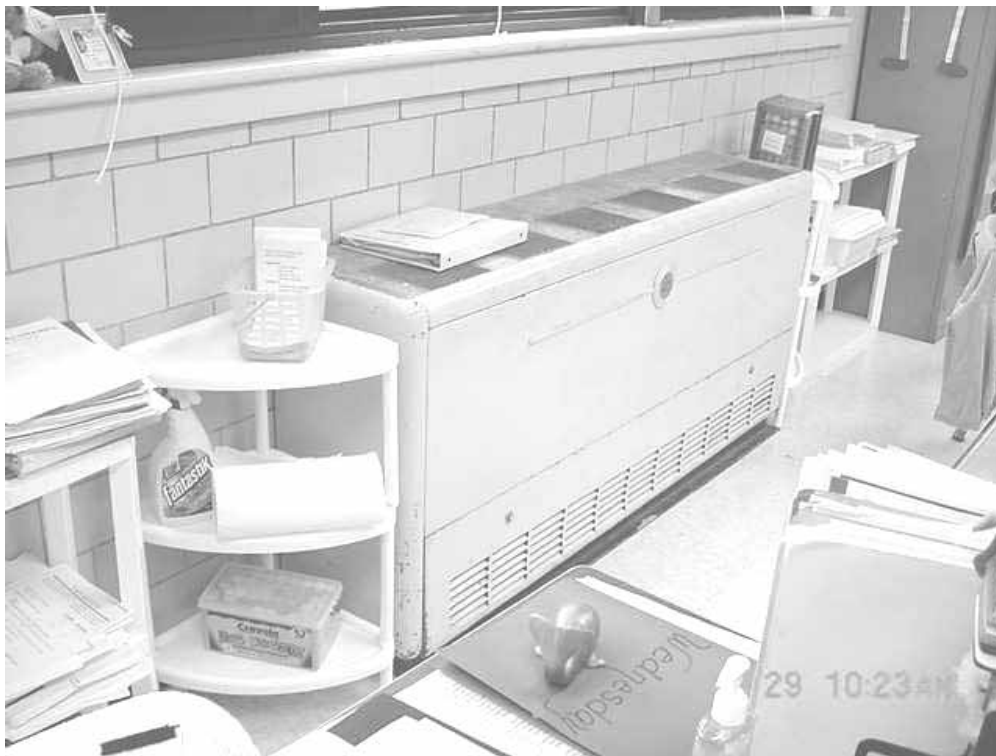
Picture 1

reportedly original equipment, approximately 50-55 years old. Univents of this age can be difficult to maintain because replacement parts are often unavailable.

Classroom Univent 1950's Vintage

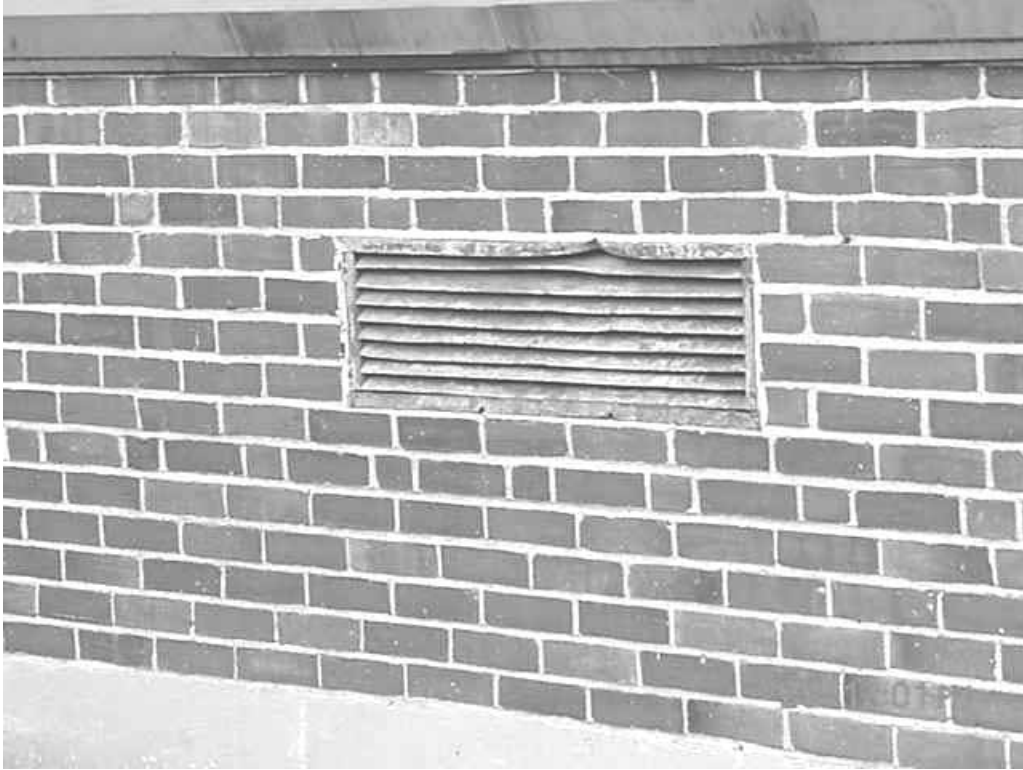
Picture 2

Univent Air Intake

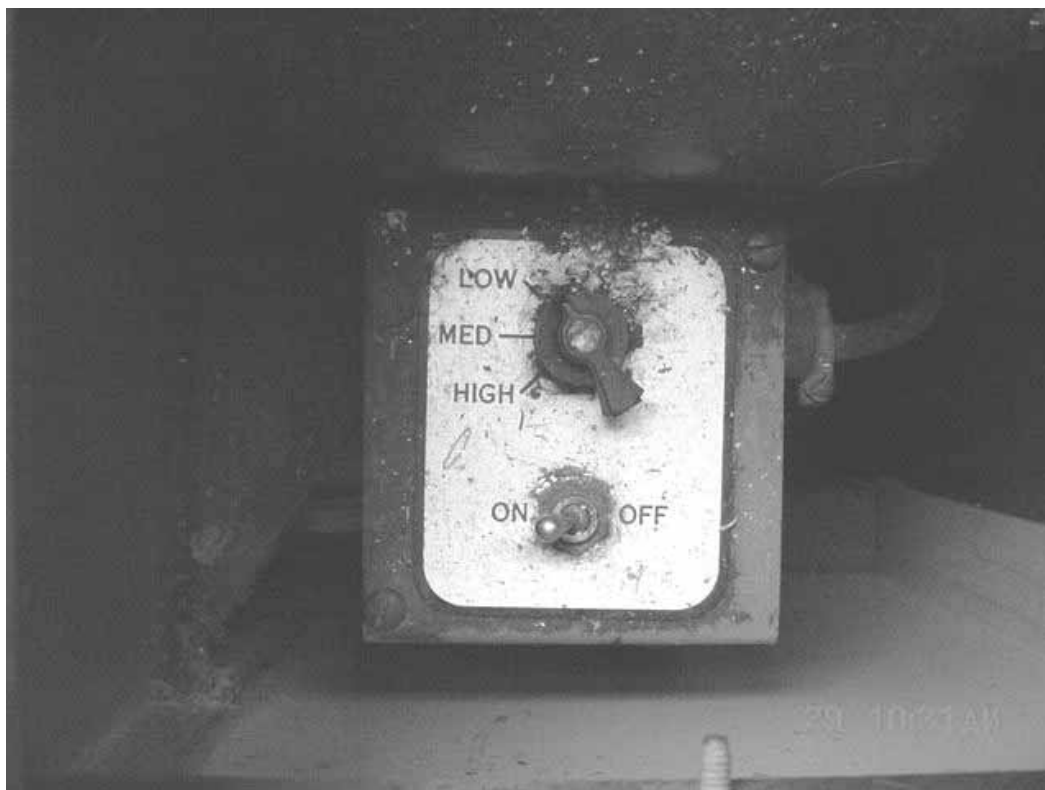
Picture 3

Univent Controls

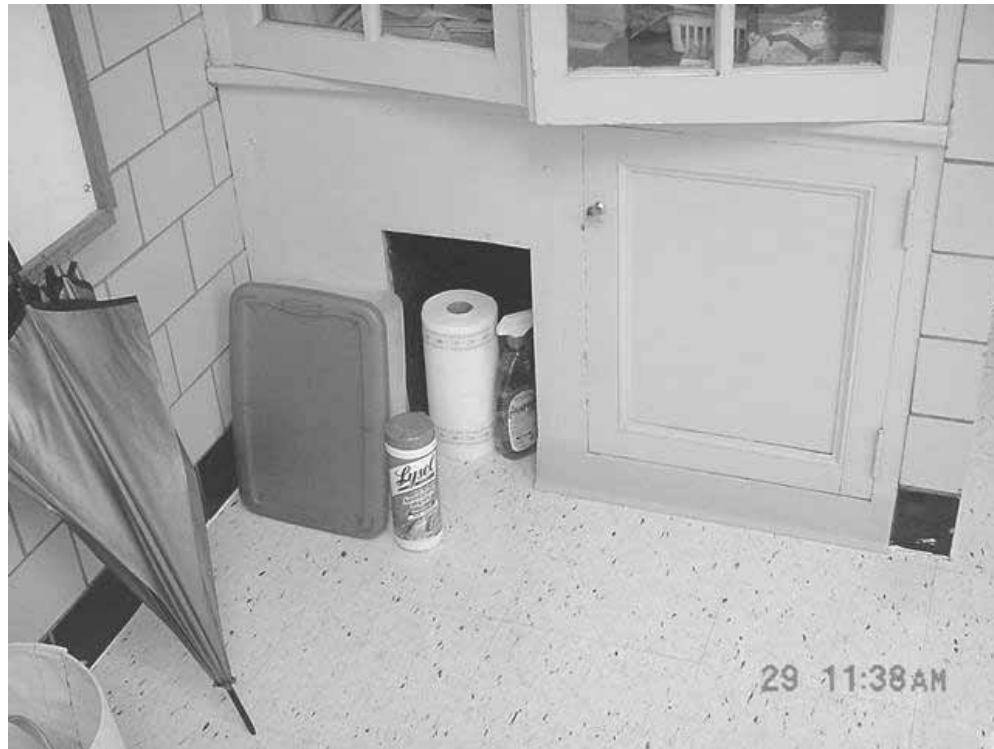
Picture 4

Exhaust ventilation in classrooms in the original building are provided by a combination of ungrated “cubby” holes located at floor level (Picture 4) and grilles located in the ceilings of coat closets (Picture 5). Air is drawn into the classroom coat closet via undercut closet doors (Picture 6). Exhaust ventilation in the 1955 addition is provided by ducted, grated wall vents powered by rooftop motors (Picture 7). A number of exhaust vents were not operating, indicating that motors were either deactivated or non-functional. School officials reported that several of the exhaust motors were on a repair list and that replacement parts had been ordered. In addition, a number of exhaust vents were obstructed by desks, bookcases and other items (Pictures 4, 5 and 7). As with the univents, in order to function properly, exhaust vents must be activated and remain free of obstructions.

“Cubby-Hole” Exhaust Vent, Note Stored Materials Within

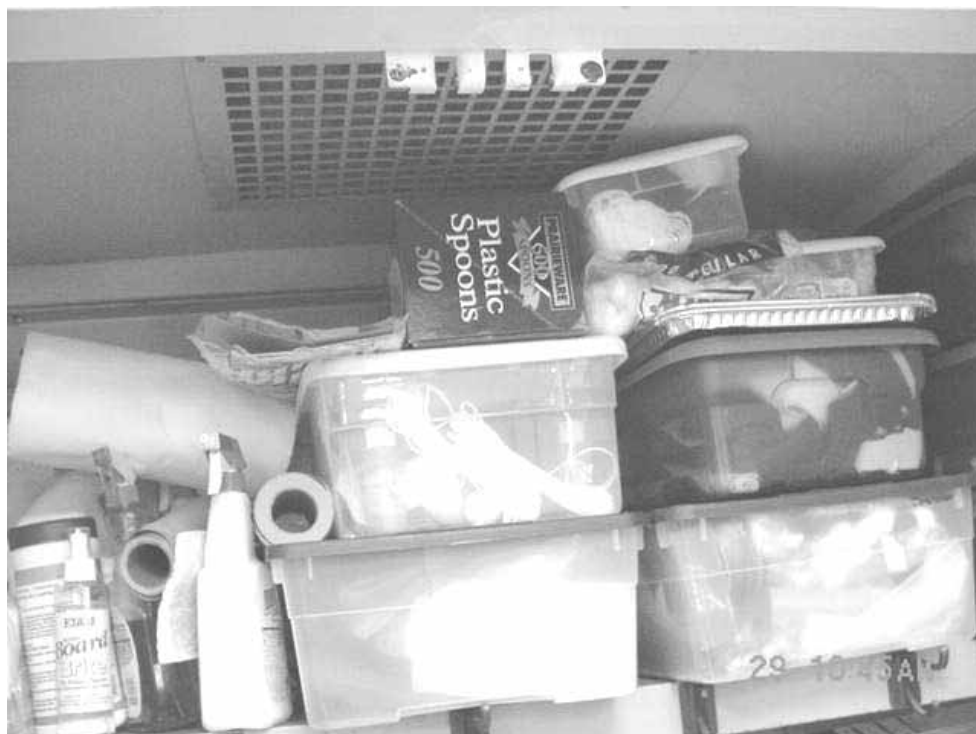
Picture 5

Coat Closet Exhaust Vent, Note Stored Materials

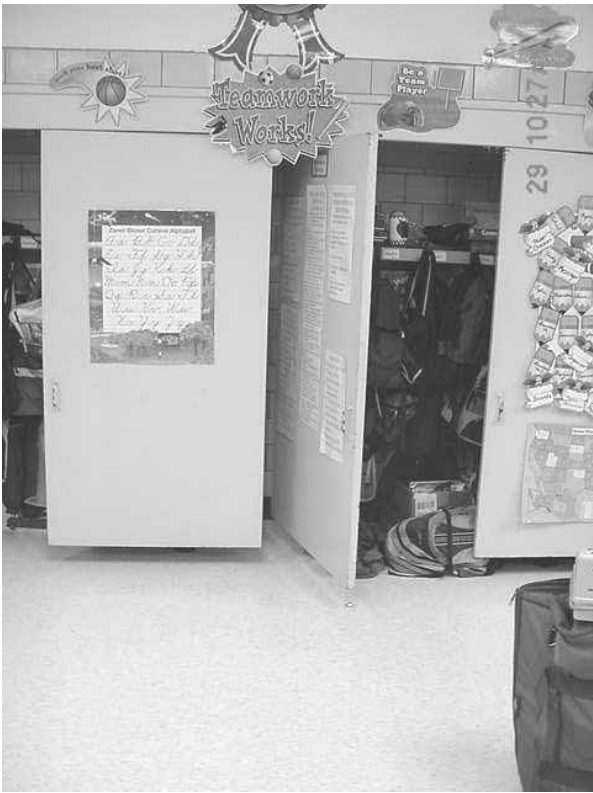
Picture 6

Undercut Coat Closet Doors

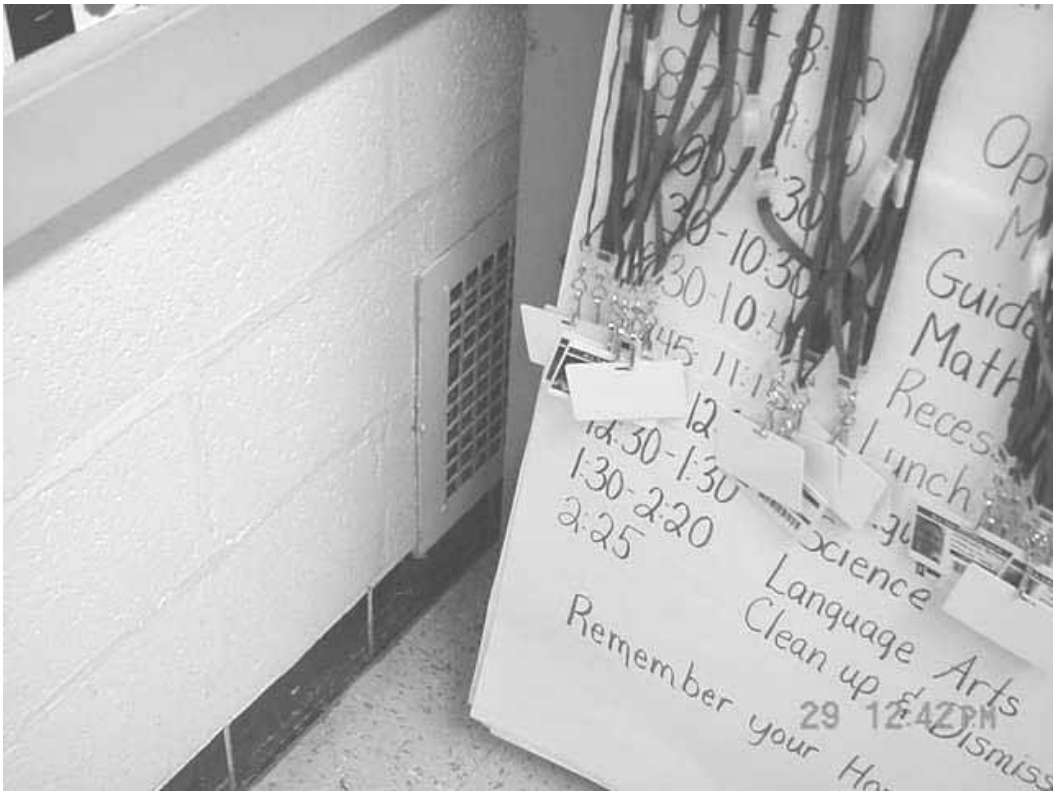
Picture 7

Partially Obstructed Exhaust Vent

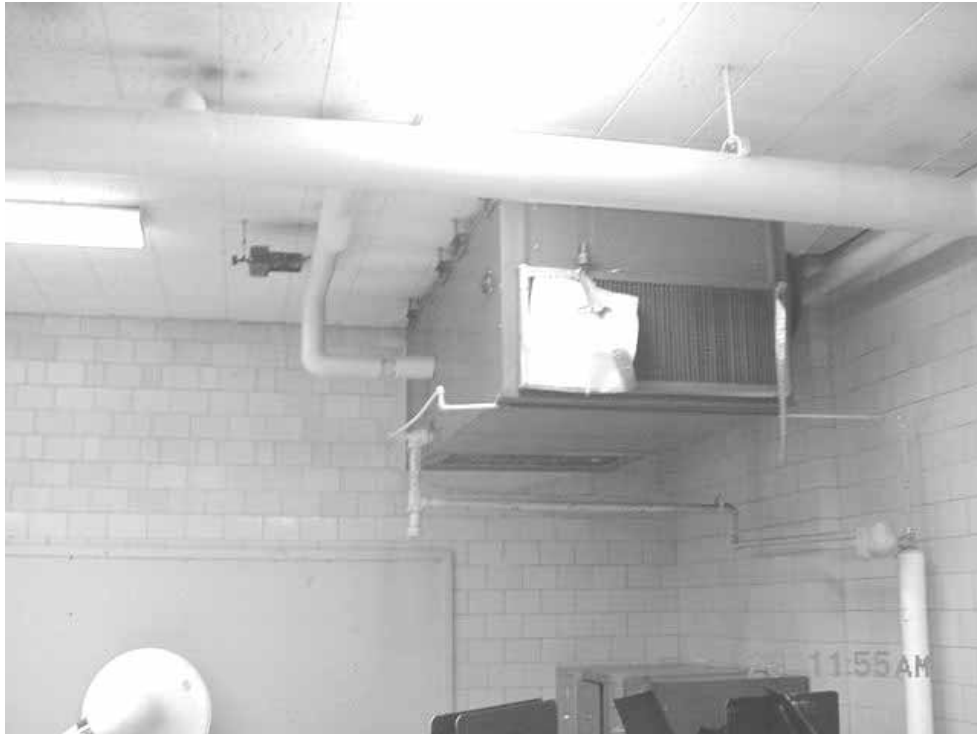
Picture 8

A number of areas throughout the building (cafeteria, gymnasium, music room) were designed to be ventilated by air handling units (AHUs). The unit in the music room was not operating, but rather sealed with fiberglass insulation and appeared to have been deactivated for some time (Pictures 8 and 9). Portions of the mechanical ventilation system in both the cafeteria and gymnasium have been removed. The cafeteria currently has no mechanical ventilation but relies solely on openable windows for air exchange.

Deactivated AHU in Music Room

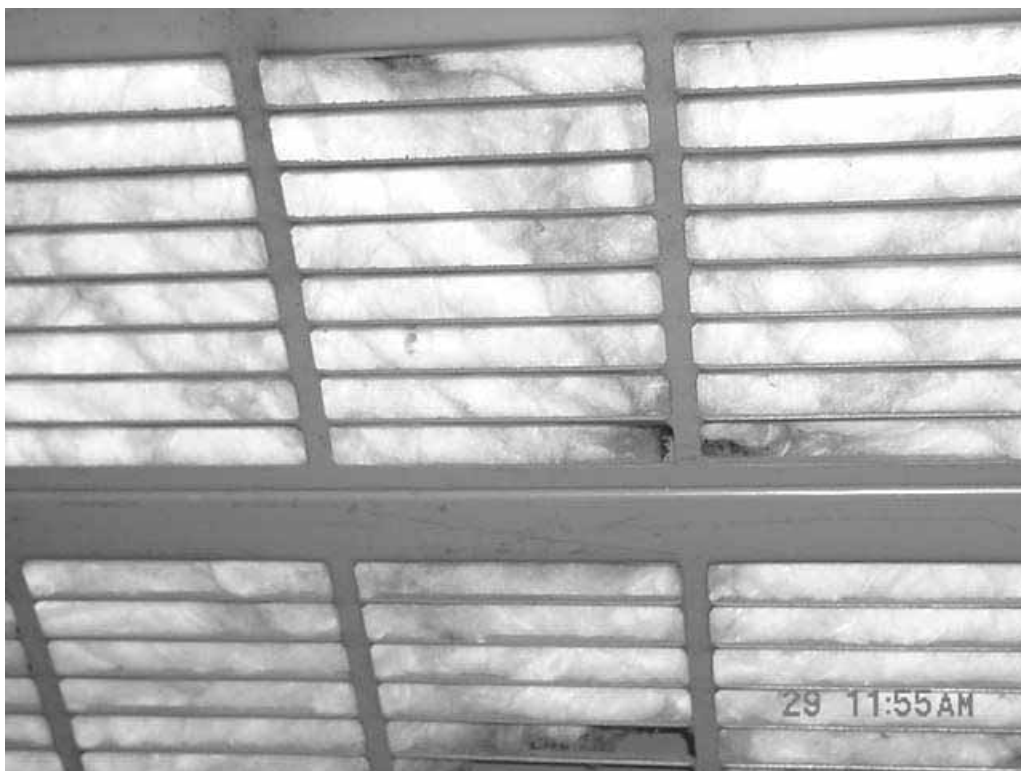
Picture 9

Close-up of Supply Vent Stuffed with Fiberglass Insulation in Music Room

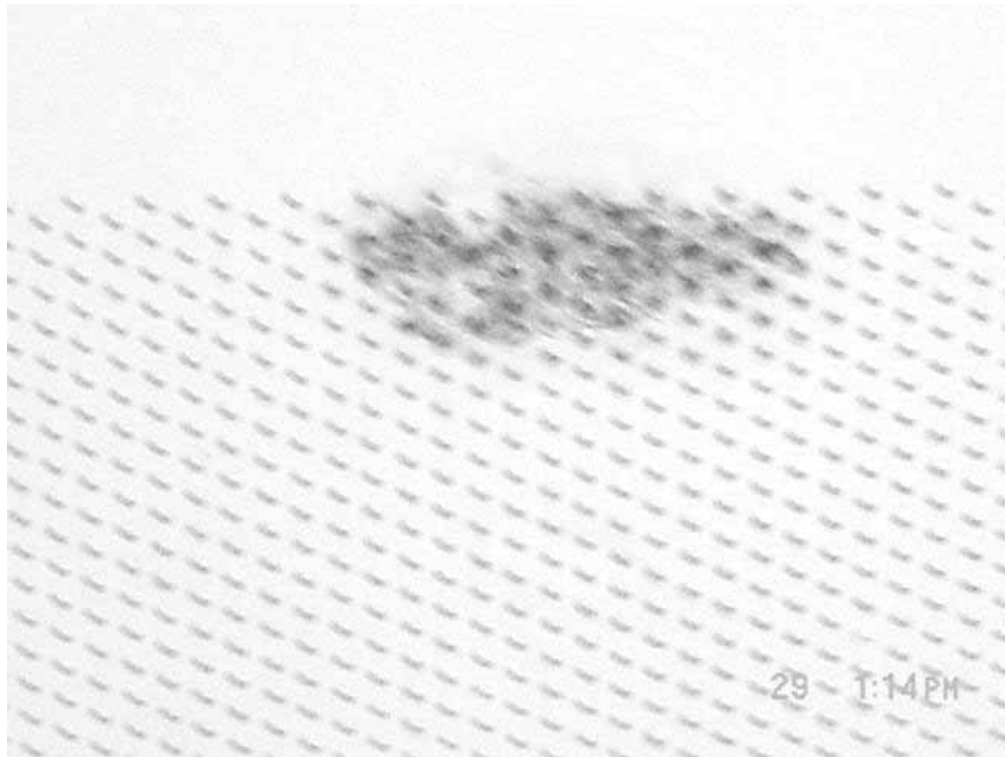
Picture 10

The 1955 addition has a ceiling that consists of sheet-metal panels. Several of these panels had dark staining that appeared to be mold growth (Table 1/Picture 10). Potential mold growth was also observed on the surface of wood molding in the music room. Since the sheet-metal and molding are non-porous surfaces, BEHA staff recommended cleaning the surface

Dark Stain (Possible Mold Growth) on Metal Ceiling Panels in 1955 Addition

mold with bleach and water and/or using a high efficiency particulate arrestance (HEPA) equipped vacuum with a brush attachment.

7. Ensure roof leaks are repaired and repair/replace any remaining water-stained ceiling tiles and/or plaster.
8. Clean mold growth on the surface of metal ceiling panels with bleach and water and/or using a HEPA vacuum with a brush attachment. Examine areas above these tiles for microbial growth. Disinfect with an appropriate antimicrobial where necessary.

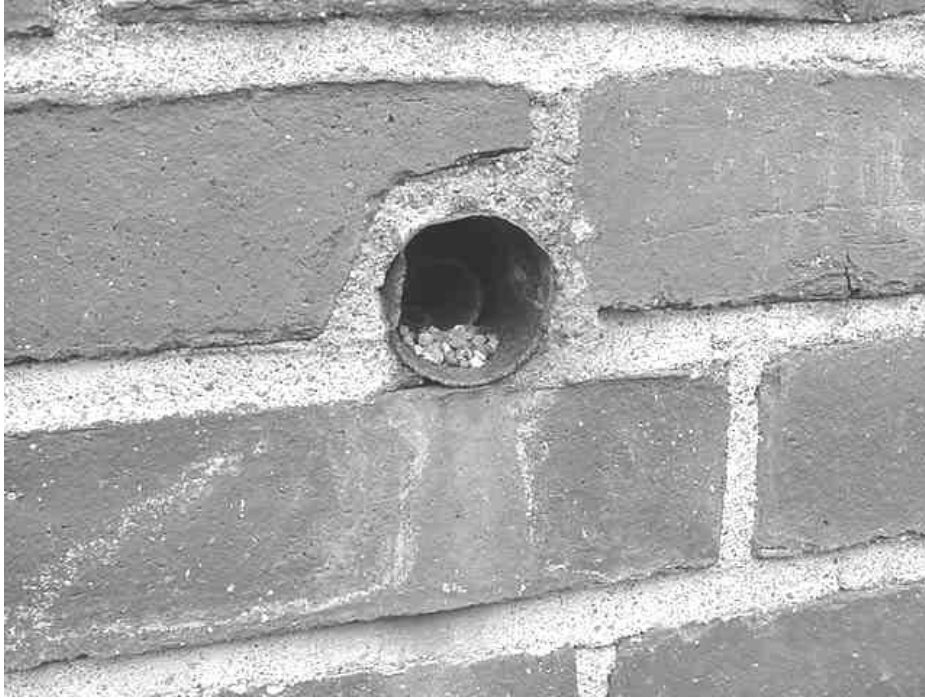
Picture 11

Several potential pathways for moisture to enter the building were identified. BEHA staff observed open utility holes in exterior walls (Picture 11) and large cracks in the cement foundation (Pictures 12 and 13). Repeated water penetration can result in the chronic wetting of building materials and potentially lead to microbial growth. In addition, these large cracks/holes in the exterior wall may provide a means of egress for pests/rodents into the building.

Open Utility Hole in Exterior Brick

9. Seal utility holes on exterior of building with a foam insulation material.
10. Repair cracks/breaches in foundation to prevent water penetration, drafts and pest entry.

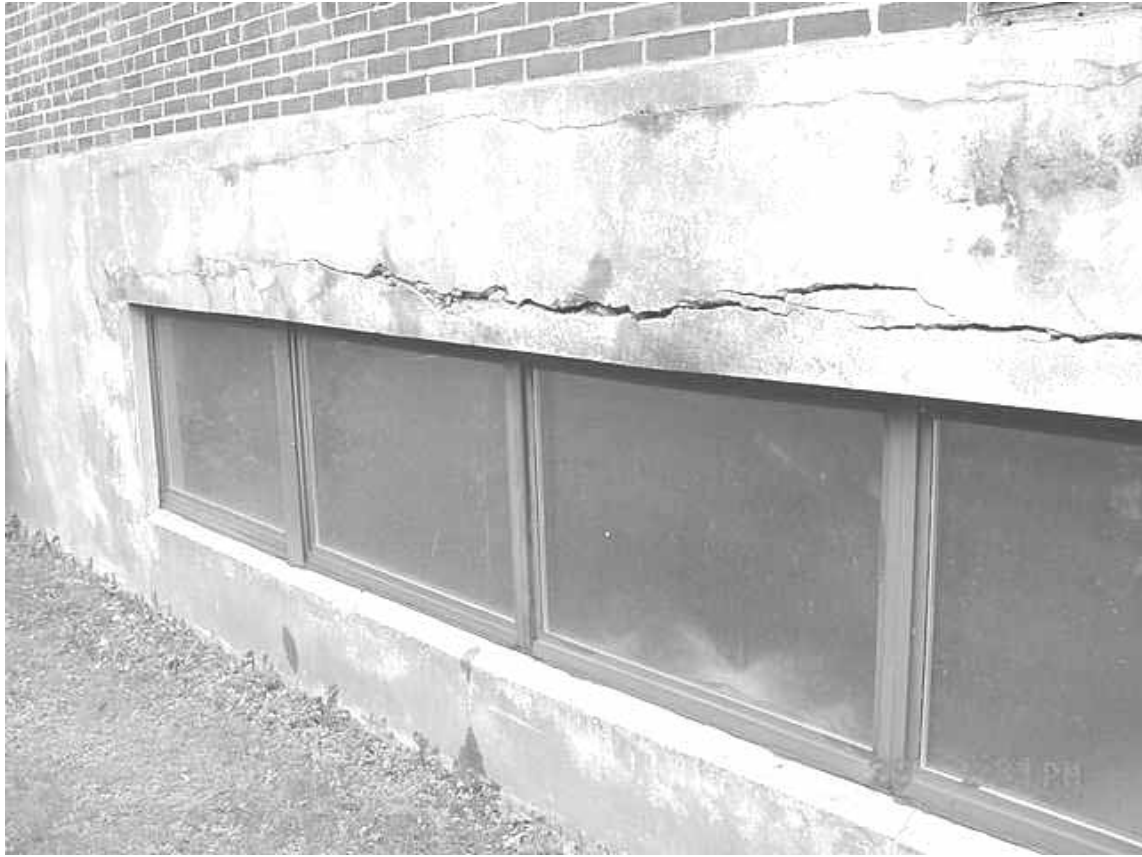
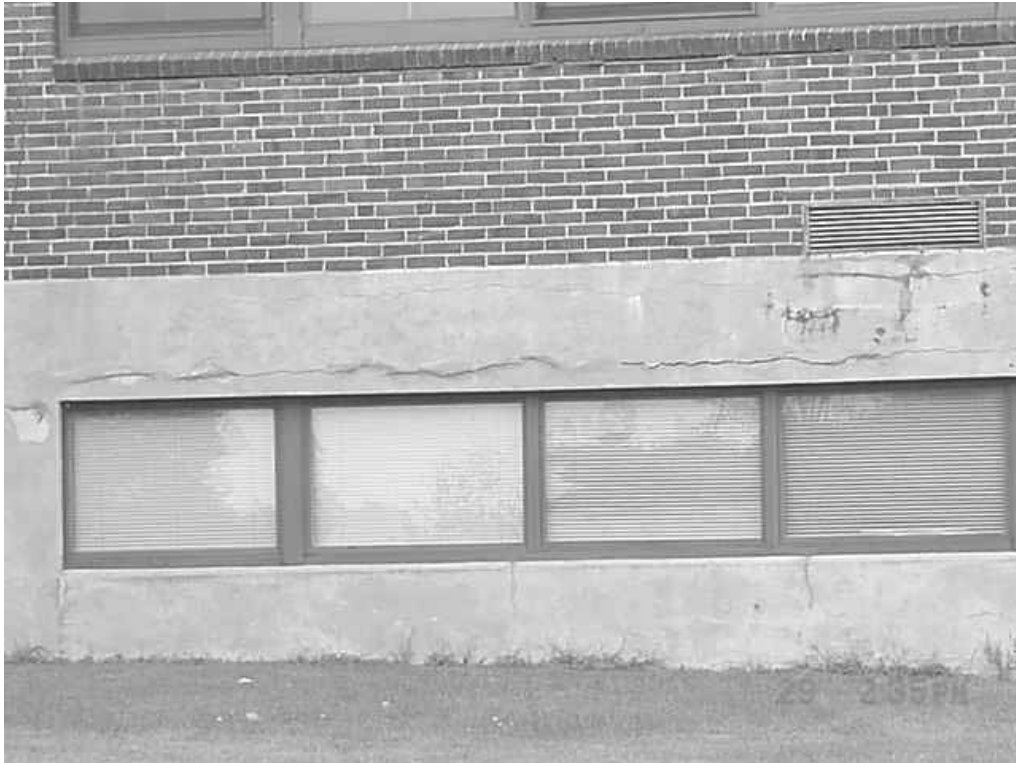
Large Crack/Breach (Above Windows) in Foundation Cement

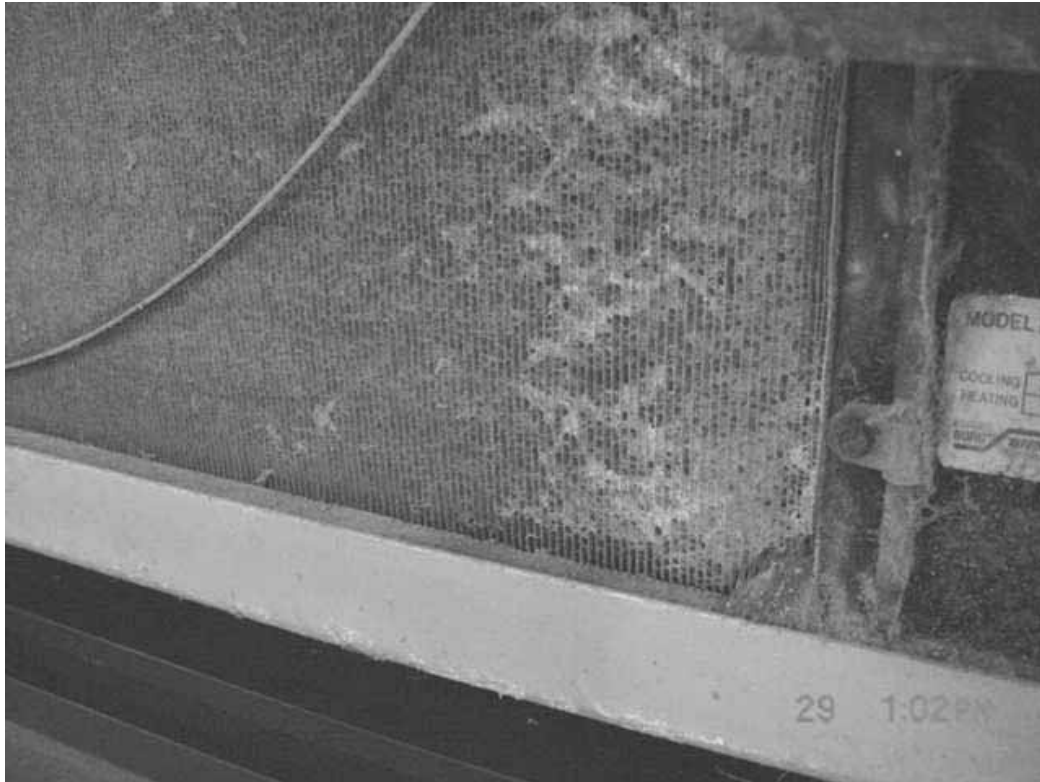
Picture 14

Several other conditions that can affect indoor air quality were noted during the assessment. Univents in the original building had accumulated dust, cobwebs and debris within the air handling chambers and on filters. Several window-mounted air conditioners (ACs) were installed in classrooms. These units are also normally equipped with filters, which should be cleaned or changed as per the manufacturer's instructions. BEHA staff removed the covers of several ACs to examine the interior of the units and found no filter media installed and the cooling fins occluded with dust and debris (Picture 14). In order to prevent the equipment from serving as a source of aerosolized particulates, BEHA staff recommended changing/installing filters and cleaning the air handling sections of the univents and AC's *prior to re-activation*.

Dust and Debris in Cooling Fins of Classroom AC with no Filter Media Installed

12. Change filters for air-handling equipment (e.g., univents, AHUs and ACs) as per the manufacturer's instructions or more frequently if needed. Vacuum interior of units prior to activation to prevent the aerosolization of dirt, dust and particulates. Ensure filters fit flush in their racks with no spaces in between allowing bypass of unfiltered air into the unit.

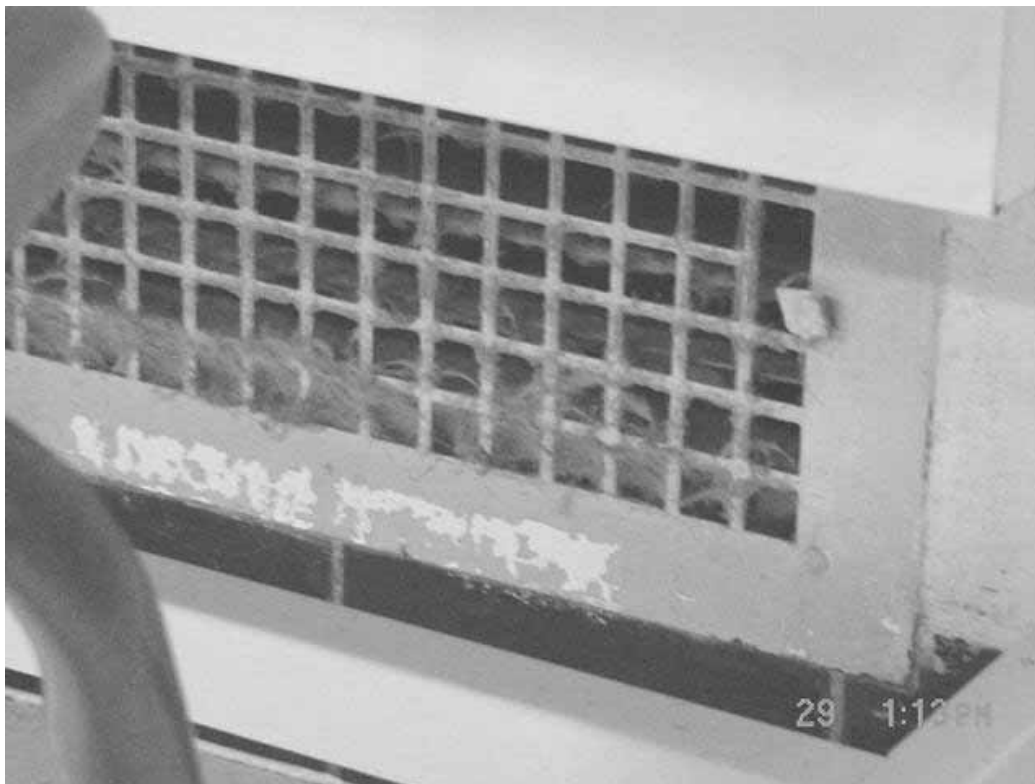
Picture 15

A number of exhaust vents in classrooms and restrooms also had accumulated dust (Picture 15). If exhaust vents are not functioning, backdrafting can occur, which can re-aerosolize dust particles. In addition, these materials can accumulate on flat surfaces (e.g., desktops, shelving and carpets) in occupied areas and subsequently be re-aerosolized causing further irritation. Dust can be irritating to eyes, nose and respiratory tract.

Dirt/Dust Build-Up in Classroom Exhaust Vent

13. Clean univent return vents and exhaust vents periodically of accumulated dust.
14. Relocate or consider reducing the amount of materials stored in classrooms to allow for more thorough cleaning. Clean items regularly with a wet cloth or sponge to prevent excessive dust build-up.

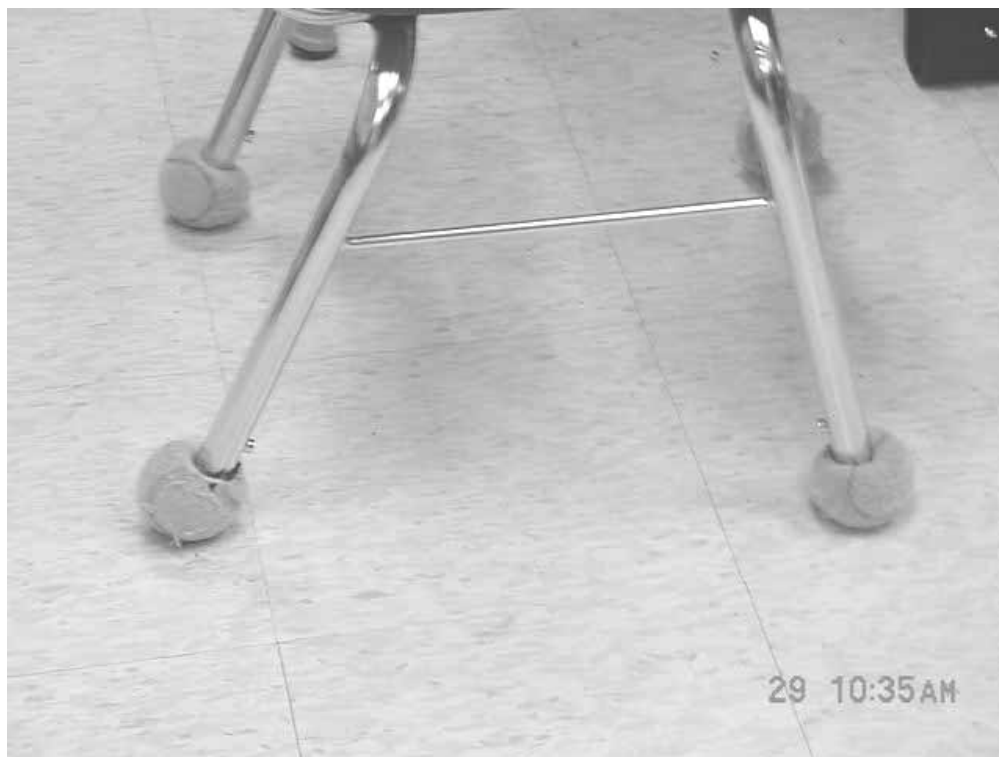
Picture 16

In an effort to reduce noise from sliding chairs, tennis balls had been sliced open and placed on chair legs (Picture 16). Tennis balls are made of a number of materials that are a source of respiratory irritants. Constant wearing of tennis balls can produce fibers and cause TVOCs to off-gas. Tennis balls are made with a natural rubber latex bladder, which becomes

abraded when used as a chair leg pad. Use of tennis balls in this manner may introduce latex dust into the school environment. Some individuals are highly allergic to latex (e.g., spina bifida patients) (SBAA, 2001). It is recommended that the use of materials containing latex be limited in buildings to reduce the likelihood of symptoms in sensitive individuals (NIOSH, 1997). A question and answer sheet concerning latex allergy is attached as [Appendix B](#) (NIOSH, 1998). In many areas, alternative “glides” are used on chair legs (Picture 17), school officials reported that more of these glides are on order to replace tennis balls.

Tennis Balls on Chair Legs

17. Continue with plans to replace tennis balls on chair legs with alternative “glides”, as illustrated in Picture 17, to prevent latex dust generation.

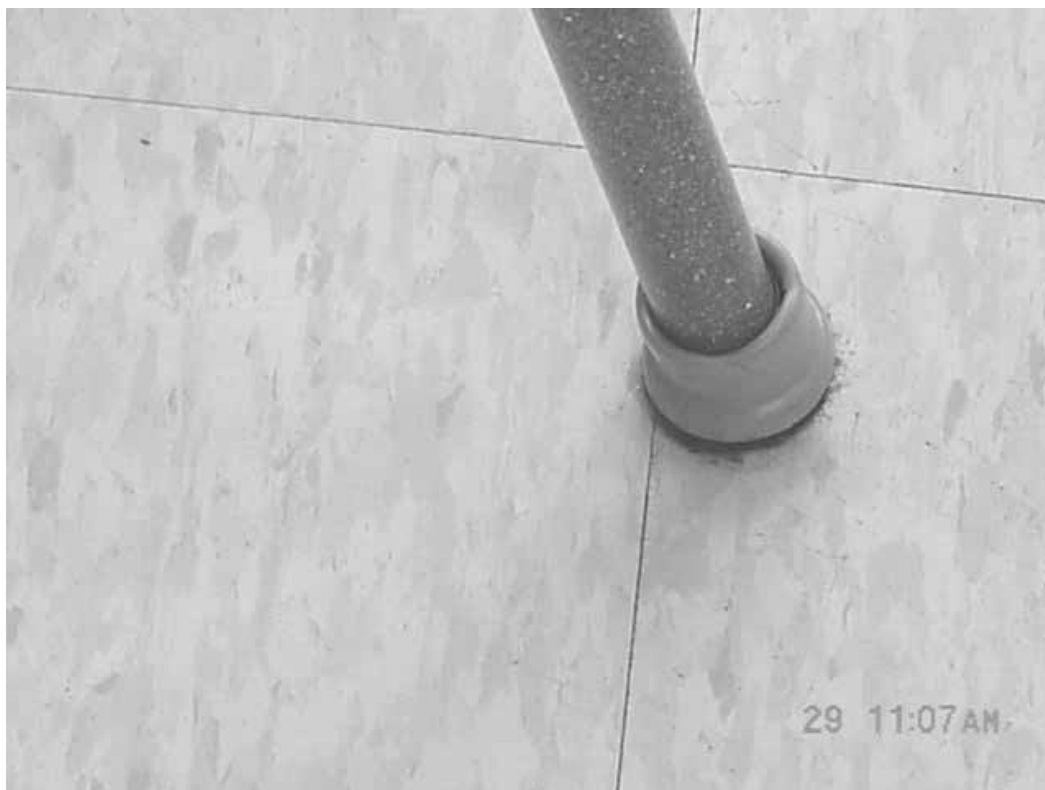
Picture 17

“Glides” on Bottom of Chair Legs
